Letting Go in the Face of Climate Change

By Laura L. Knott, March 10, 2020

Lane's Mill Park

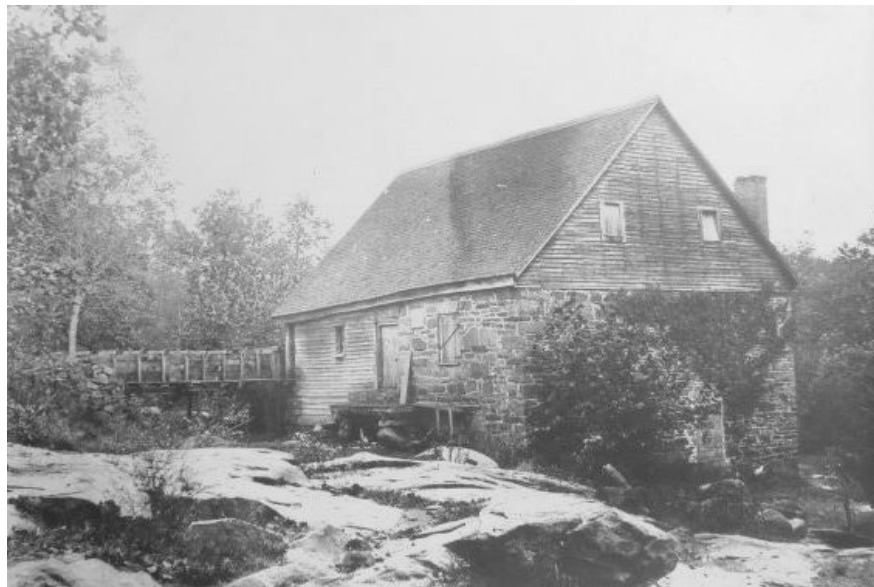
Figure 1. Photograph of Lane's Mill ca. 1910. Courtesy of Fairfax County Park Authority.

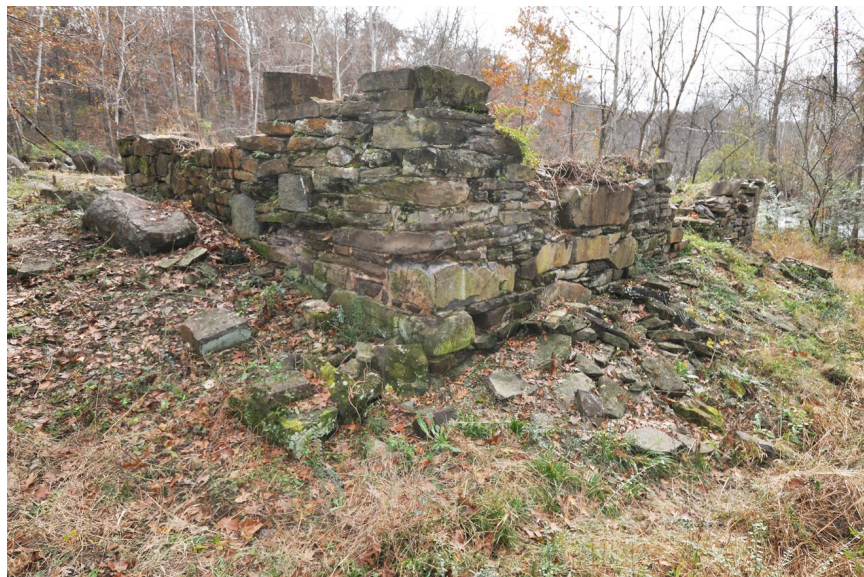
Next, the team documented existing conditions at the site, including written descriptions and photographs of the mill ruins from a variety of viewpoints. Alfonso Narvaez of Aeon Preservation, who specializes in materials and structural conservation, took an active role in this phase of the project, assessing issues around condition, deterioration, and public safety. Aeon determined that overall, the ruins were in poor condition with portions highly unstable with degrading materials that will lead to continued progressive collapse (Figure 2).

Figure 2. Photograph of Lane's Mill in 2018 by Alfonso Narvaez.

The team found that the primary cause of the deterioration of the mill structures was Lane's Mill Park's location at the confluence of the two suburban streams, which makes it vulnerable to repeated, serious flooding. The site is now subject to frequent and heavy flooding caused by increased development in the watersheds of Cub Run and Big Rocky Run, exacerbated by climate change. Between 1980 and 2000, the population within the Cub Run Watershed grew almost 500% with an associated impervious cover increase of around 265%. Centreville, in which Lane's Mill Park is located, was identified as one of the areas of significant development within the watershed.

Due to the mill's low integrity and ongoing threats, the team recommended that the Park Authority should adopt the philosophy of non-intervention in dealing with the site, proposing adaptation to, rather than resistance to, the processes of deterioration, and acceptance of the eventual loss of the Lane's Mill structures. The recommendations were presented in four categories: documentation, vegetation management, public safety, and interpretation.

- **Documentation:** Of primary importance is documentation of this historic resource before it is completely lost. This can be accomplished by first, completing a LiDAR survey of all the mill structures, and second, continuing archaeological investigations at the site to recover as much information as possible about the mill before remaining resources are lost.

- **Vegetation Management:** Despite periodic efforts to clear the site, the Lane's Mill ruins very quickly become overgrown with opportunistic trees, vines, shrubs, and grasses, some identified as regionally invasive. Overgrown vegetation not only blocks views to the remnant mill structures, it also contributes to their deterioration. Vegetation management is a crucial part of maximizing interpretation at the site so that the public can see the major structures of the site from adjacent trails, not only to observe the ruins themselves, but to witness their changing conditions over time. In addition, vegetation management is also important for maximizing protection of the site without other intervention. Vegetation management at Lane's Mill Park should focus on the control of invasive species, particularly those that inhibit views of the structures or that contribute to destabilization.

- **Public Safety:** The ruins of Lane's Mill present a certain amount of danger to persons who may attempt to climb them or explore the site. Walking surfaces are unstable, there are a number of high ledges with no protective barrier, and some lengths of the mill walls are unstable and could topple. In order to protect public safety at the site, the Park Authority agreed that the placement of a caution sign at the site is the best way to manage public safety. To minimize clutter at the site, the warning will be incorporated into the two proposed interpretive signs at the site.
